Cannulated screw unraveling: a case series and literature-based review of an under-recognized complication

Abstract Partially threaded cannulated screws have enhanced the orthopedic surgeon's ability to fix periarticular fractures. There are many reports of complications and hardware failure during screw removal, but those during fracture fixation are under-reported and under-recognized in the literature. We describe a 21-year-old healthy man with a grade 1 open displaced medial epicondylar humerus fracture. Upon fracture fixation in the OR using a partially threaded cannulated screw over a Kirschner wire, the threads of the screw unraveled. The operating surgeon felt increased resistance and the unraveling was demonstrated on intra-operative fluoroscopy. The screw was removed by hand without hardware retention and a new K-wire and cannulated screw were used for definitive fixation. We found seven previous cases reporting a similar complication with mixed presentations and results. All occurred in young healthy patients, six of which were males. Six of the seven cases made no mention of a tactile change in resistance during fixation and only one of the seven pre-drilled the cortex

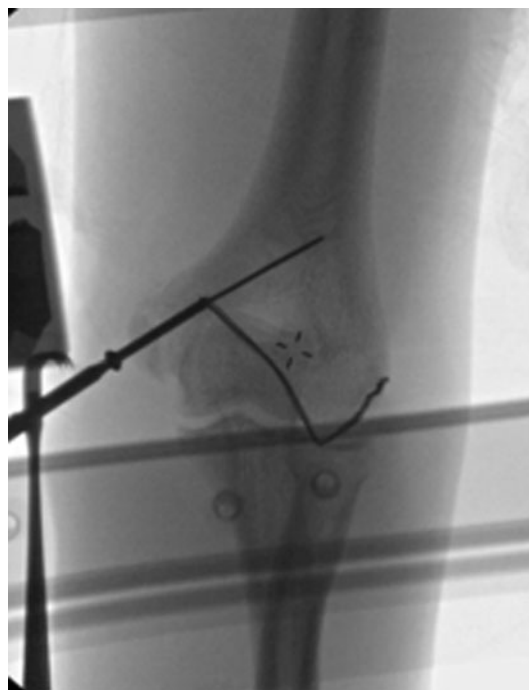
Fig. 1 Intraoperative anteroposterior fluoroscopic image showing the unraveled Synthes 4.0 mm cannulated screw over the guide wire

The operation was performed under general endotracheal anesthesia and uneventfully proceeded with irrigation, debridement, and placement of a Kirschner wire across the fracture site from the medial column of the distal humerus into the lateral column. The medial cortex was then drilled with a cannulated drill prior to placement of a 46-mm Synthes 4.0 mm partially threaded cannulated screw. While inserting the screw by hand, the surgeon recognized an unusual change in resistance, and fluoroscopic images were obtained that revealed an unraveling of the entire screw threading, accounting for about 50 % of the total screw length (Fig. 1). The decision was made to reverse the screw over the wire, which proceeded completely without fracture of the threading. The K-wire and screw were removed (Fig. 2). A new K-wire was then repositioned across the fracture, drilled over the entire length of the wire, and a second screw and washer were placed without complication. The procedure concluded uneventfully and the patient had no neurovascular injury or other complication.

An explanation for the mechanism of hardware failure was proposed by Brown [4] as a “weakness [that develops] at a portion of the self-cutting flute and then [travels] along the groove of the thread with the metallic fragment unwinding as the screw [is] inserted.” Mooney [5] noted that none of their cases involved screw contact with cortical bone and proposed that their series of young, healthy males had unusually dense cancellous bone, resulting in “catching” of the self-drilling teeth that “in combination with the rotating motion of the insertion process [causes] the screw to unravel or unwind.” Levene, Sabnis, and Chen [6–8] all suggest the same mechanism of failure in their reports as a result of the screw catching on dense cortical bone. In our case, we believe the cutting flutes engaged the dense cortical bone, which initiated and propagated the unraveling.

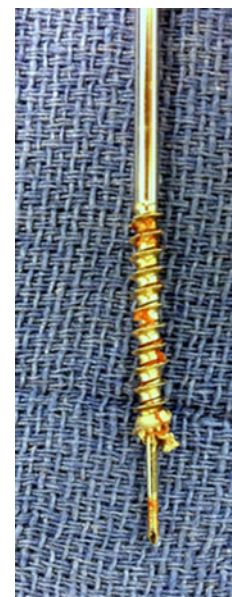
Fig. 2 Recovery of the cannulated screw and K-wire after slowly reversing with a hand-held screwdriver
